UNDERWATER BRIDGE INSPECTION REPORT

STRUCTURE NO. 66518  
CSAH NO. 1  
OVER THE  
CANNON RIVER OVERFLOW  
DISTRICT 6 - RICE COUNTY

PREPARED FOR THE  
MINNESOTA DEPARTMENT OF TRANSPORTATION  
BY  
COLLINS ENGINEERS, INC.  
JOB NO. 5221 (CEI 27A)

MINNESOTA DEPARTMENT OF TRANSPORTATION  
UNDERWATER BRIDGE INSPECTION

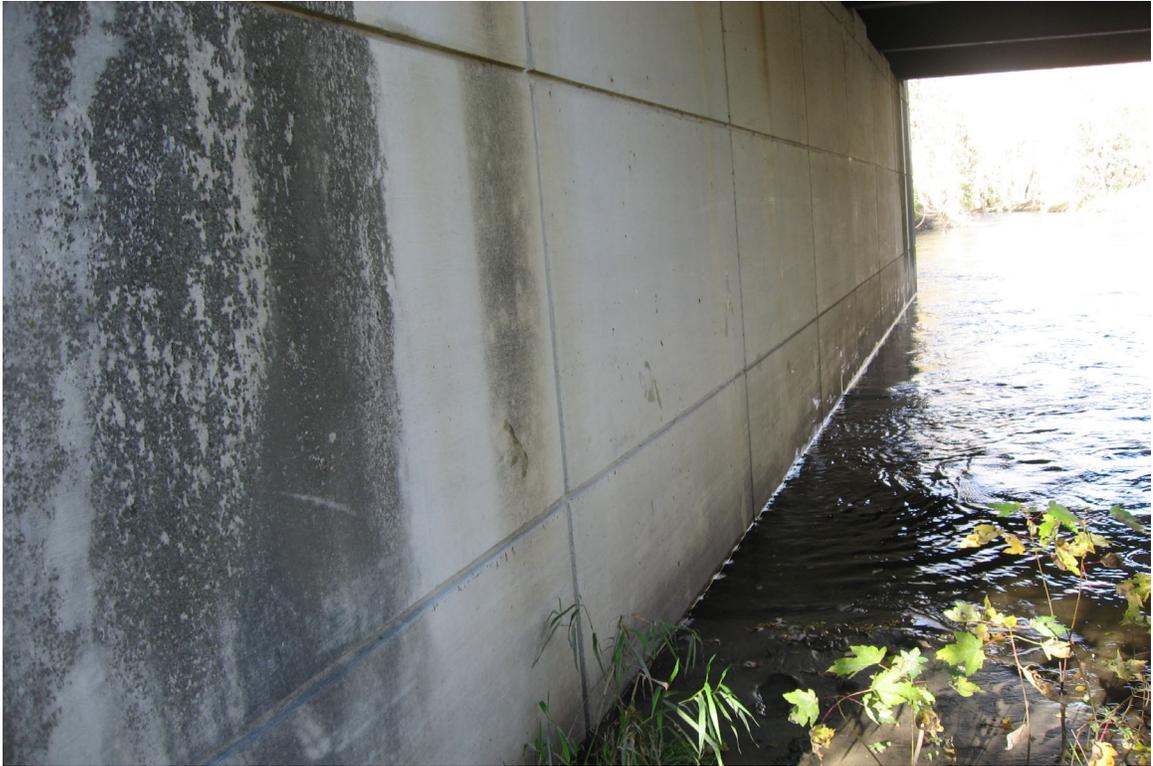
Photograph 1. View of West Abutment, Looking North.

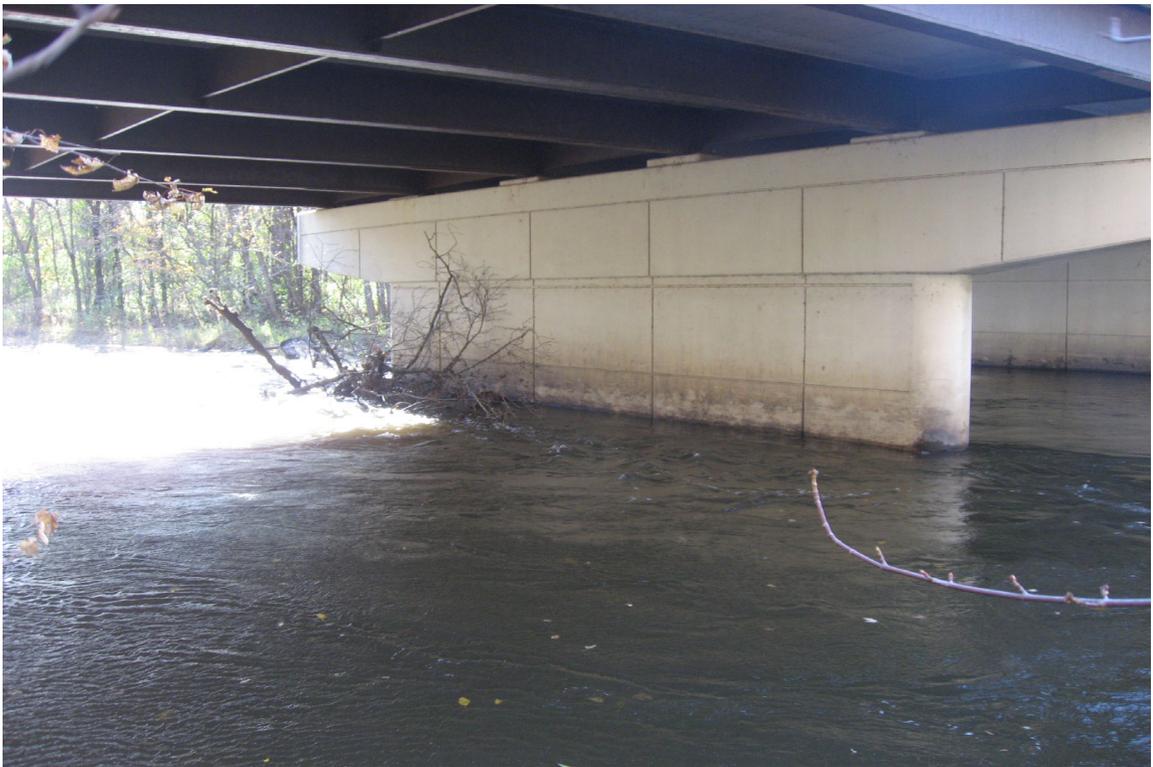
Photograph 2. View of Pier 1, Looking West.

- (A) Monitor the timber drift accumulation at the pier during future inspections, and if found to be progressing, removal may become warranted to inhibit any adverse effects for pier or surrounding channel bottom.

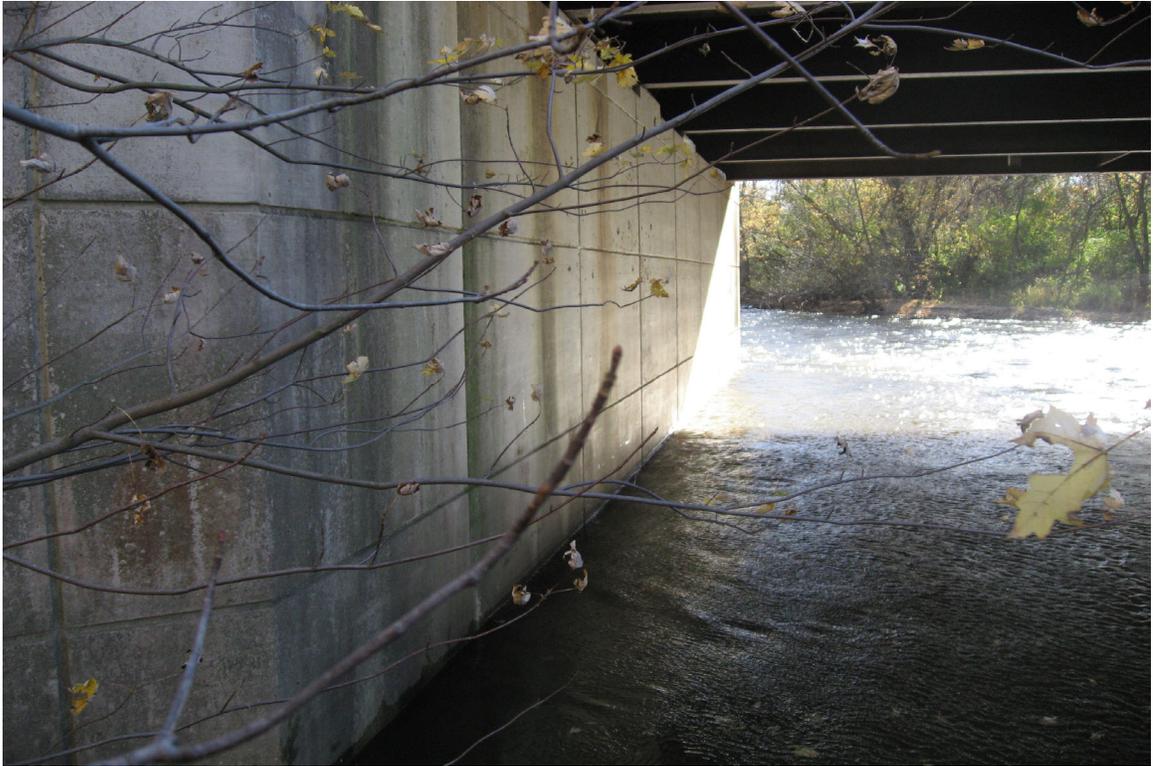
Photograph 3. View of East Abutment, Looking Southwest.

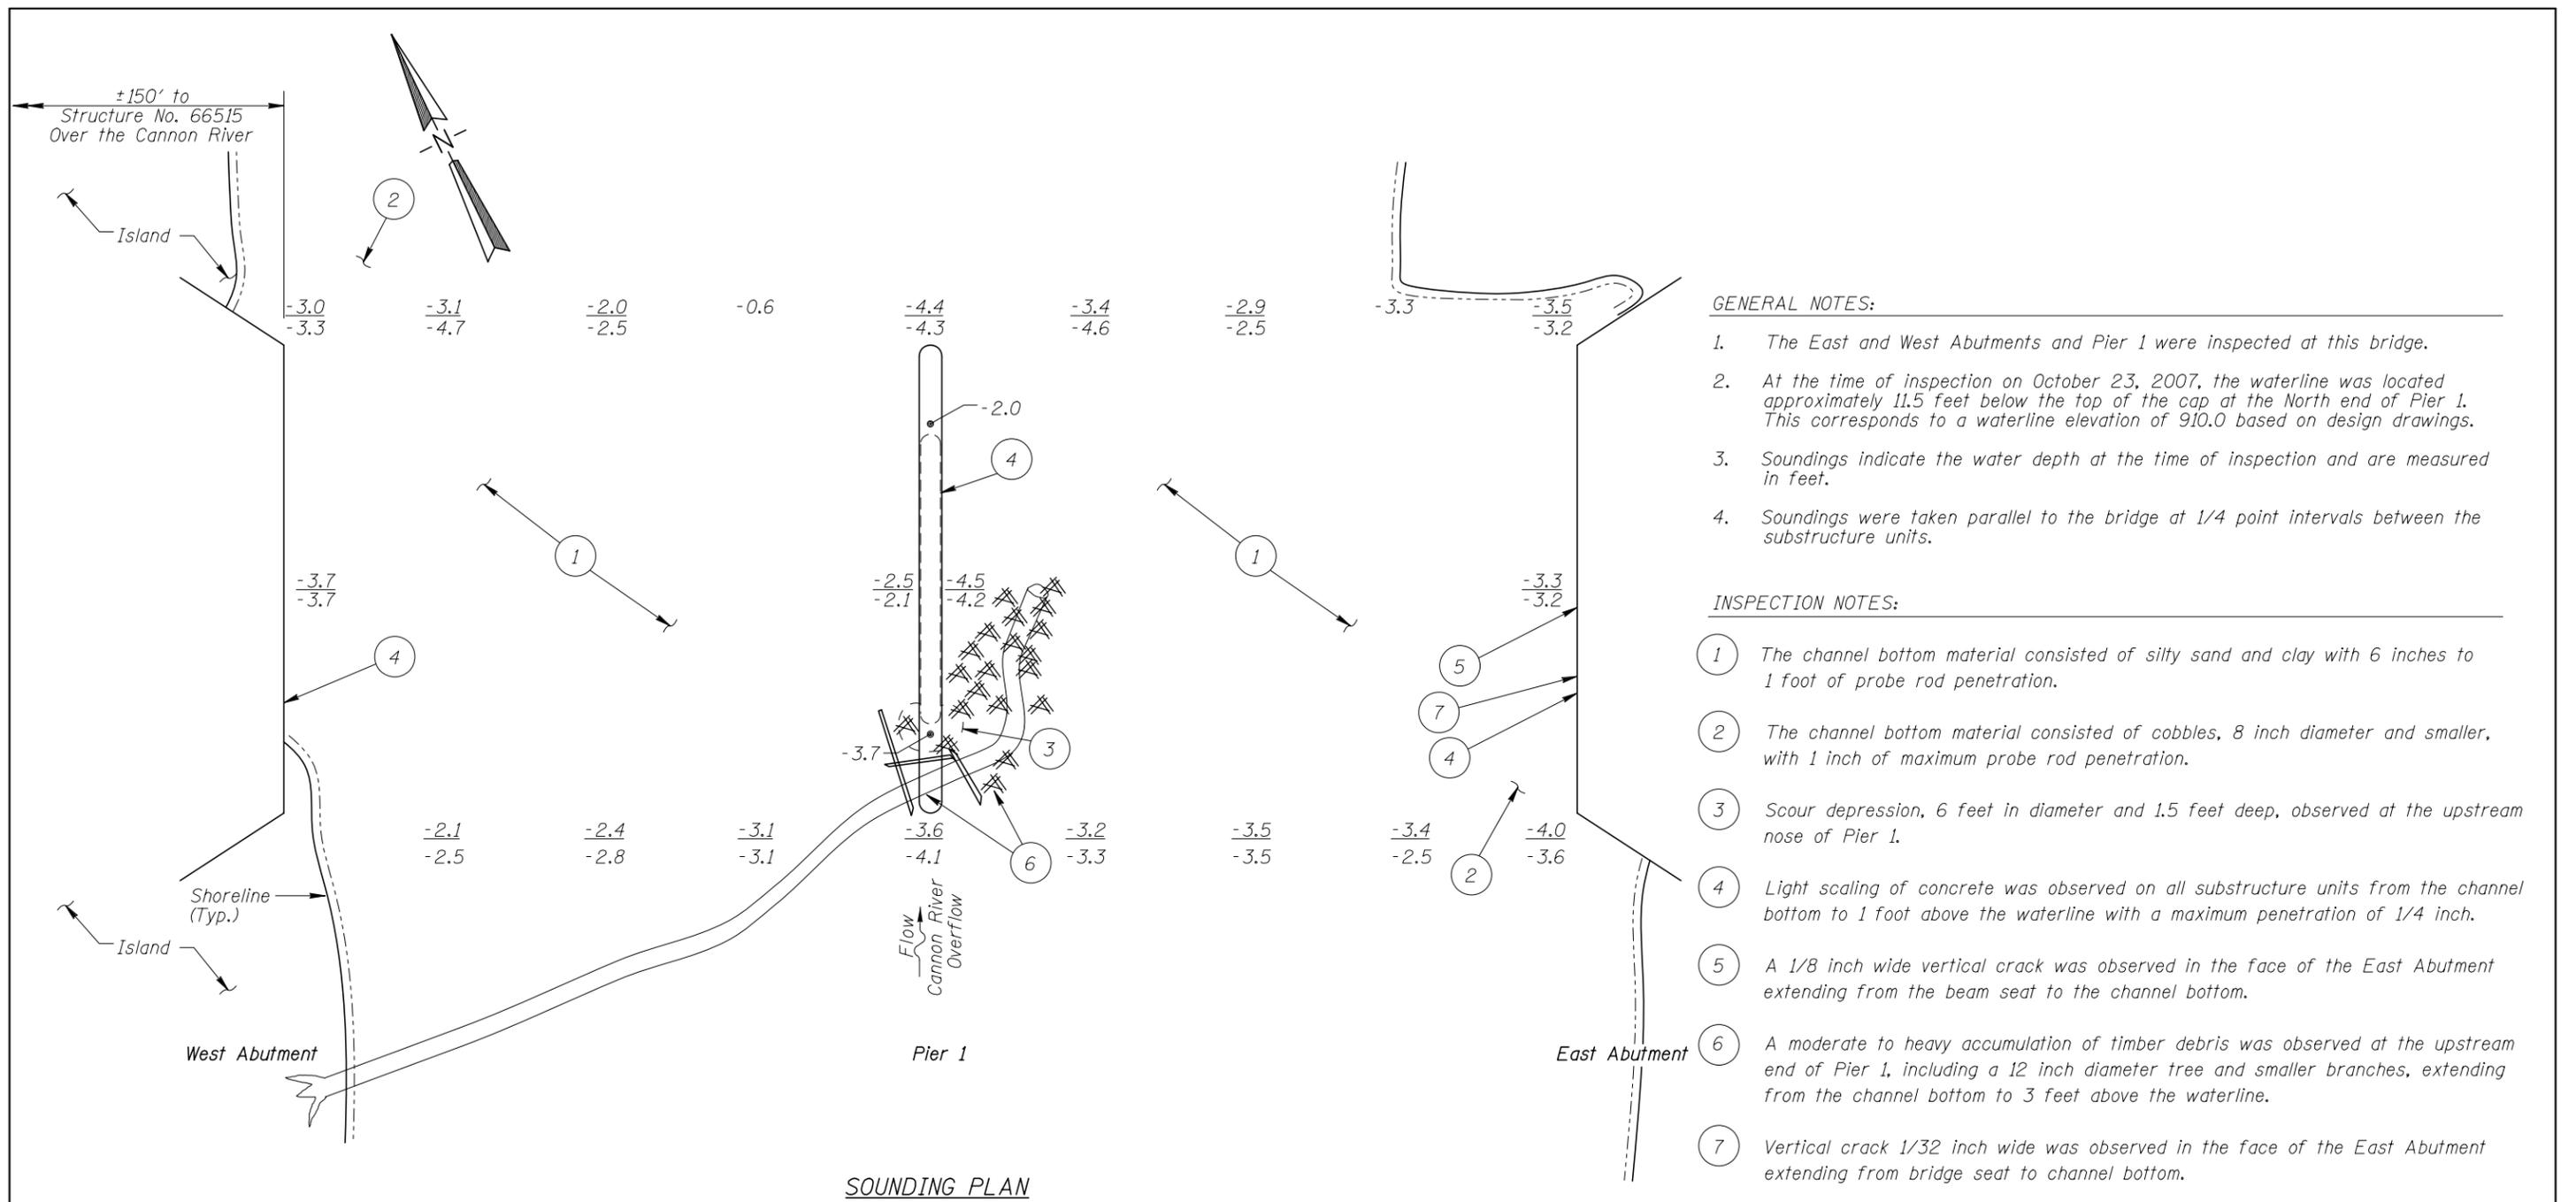
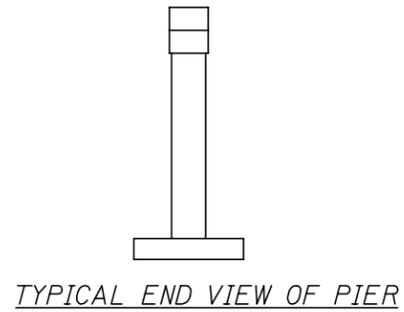
**SOUNDING PLAN**

- 1 The channel bottom material consisted of silty sand and clay with 6 inches to 1 foot of probe rod penetration.
- 2 The channel bottom material consisted of cobbles, 8 inch diameter and smaller, with 1 inch of maximum probe rod penetration.

- 3 Scour depression, 6 feet in diameter and 1.5 feet deep, observed at the upstream nose of Pier 1.
- 4 Light scaling of concrete was observed on all substructure units from the channel bottom to 1 foot above the waterline with a maximum penetration of 1/4 inch.

- 5 A 1/8 inch wide vertical crack was observed in the face of the East Abutment extending from the beam seat to the channel bottom.
- 6 A moderate to heavy accumulation of timber debris was observed at the upstream end of Pier 1, including a 12 inch diameter tree and smaller branches, extending from the channel bottom to 3 feet above the waterline.

- 7 Vertical crack 1/32 inch wide was observed in the face of the East Abutment extending from bridge seat to channel bottom.
